BAY BRIDGE ANCHOR RODS

That Fasten Shear Keys S1 & S2 to Pier E2

Report on the A354 Grade BD High-Strength Steel Rods on the New East Span of the San Francisco-Oakland Bay Bridge With Findings and Decisions

July 8, 2013

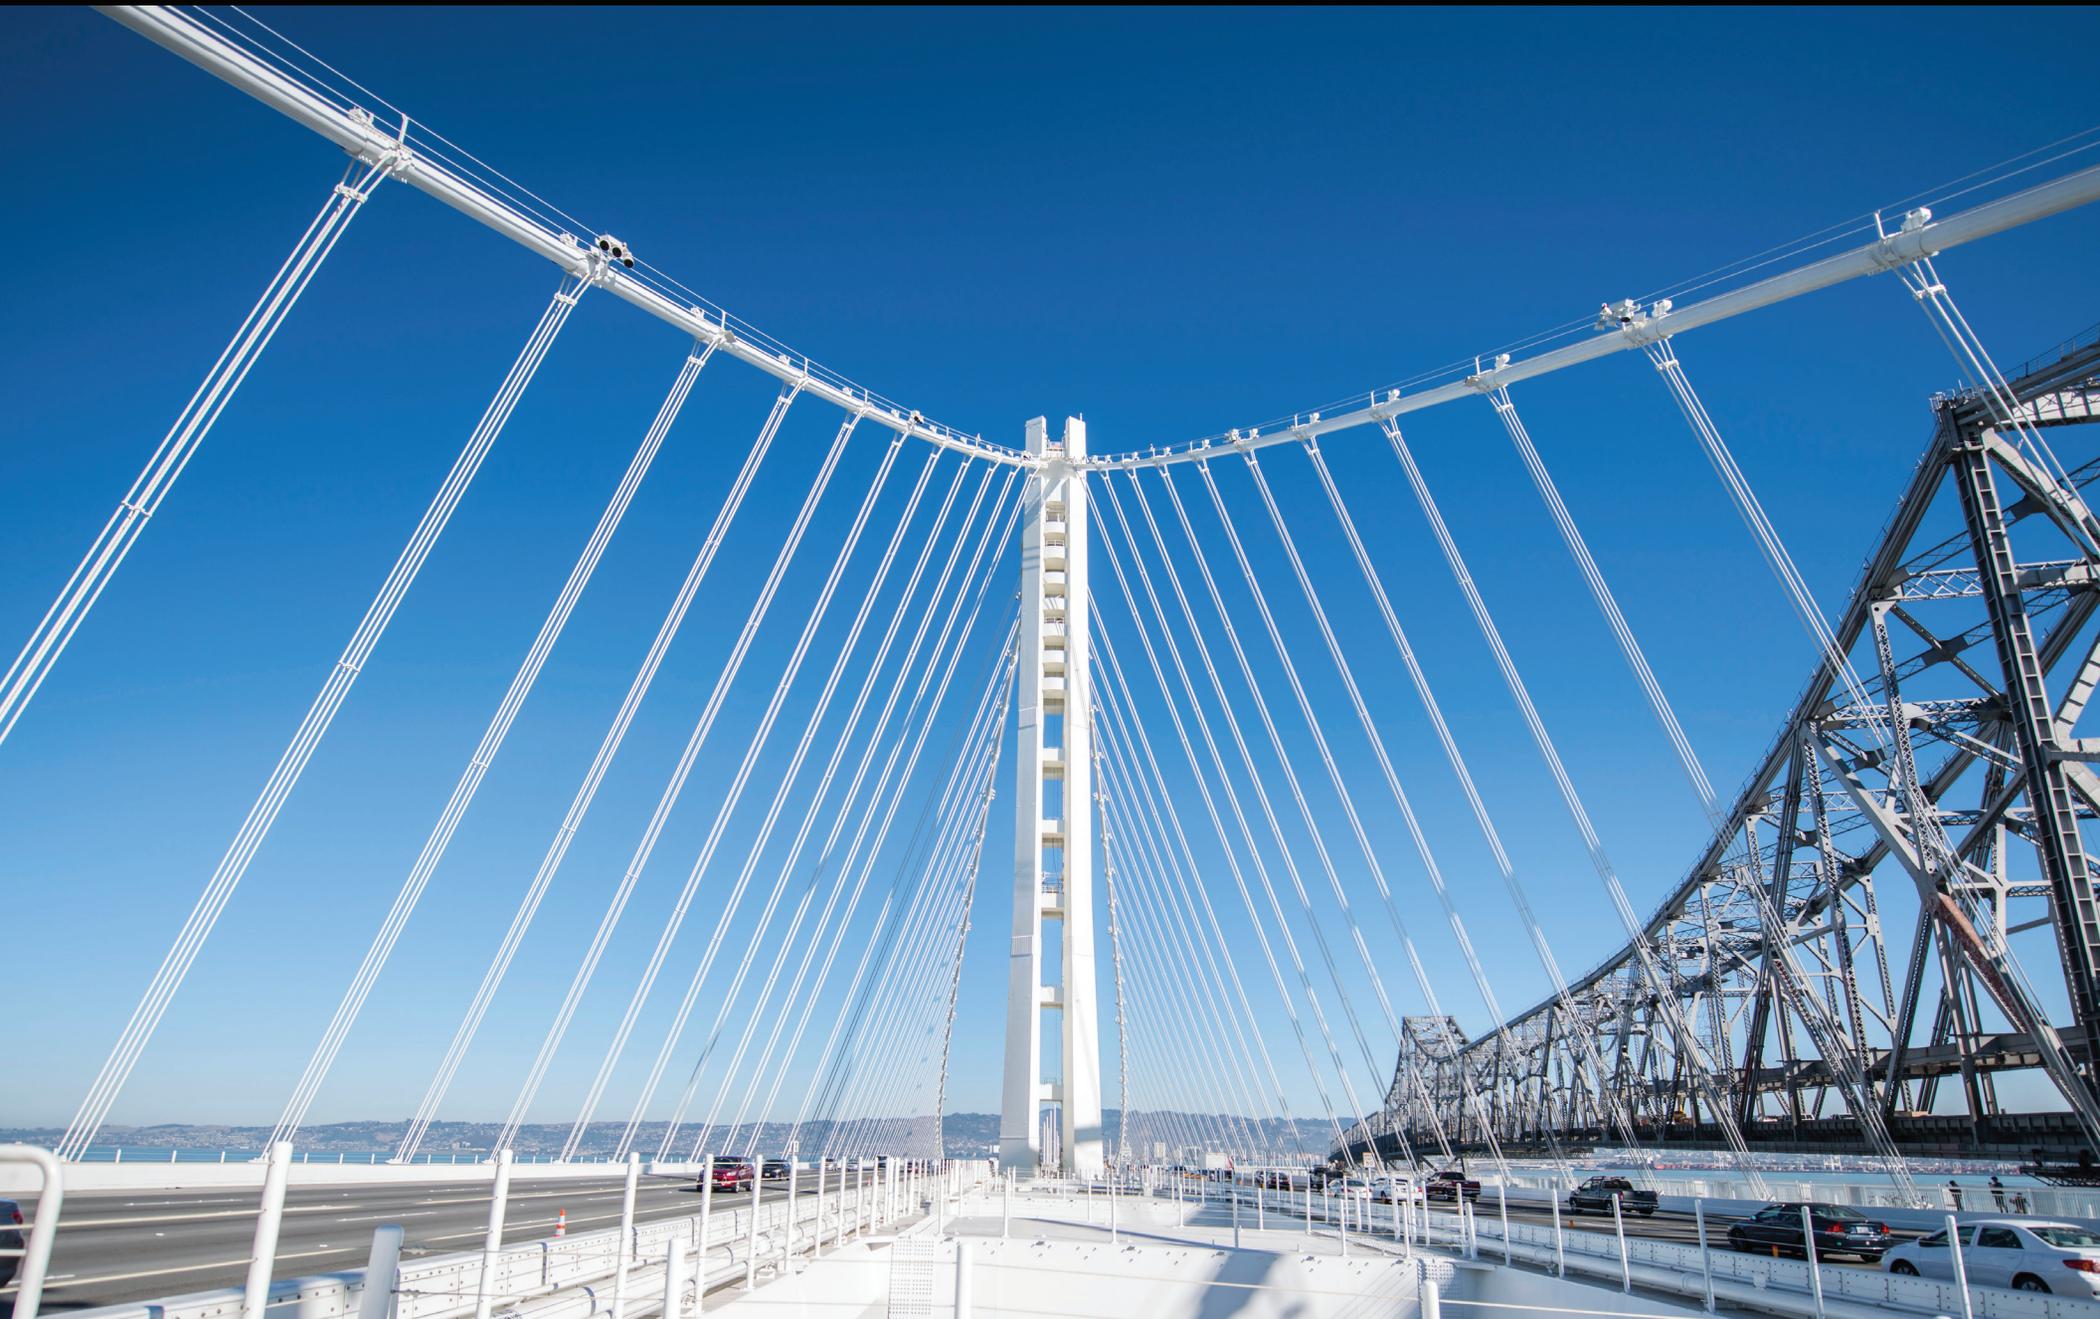
THE MESS:

- Grade BD steel is installed & cannot be economically replaced

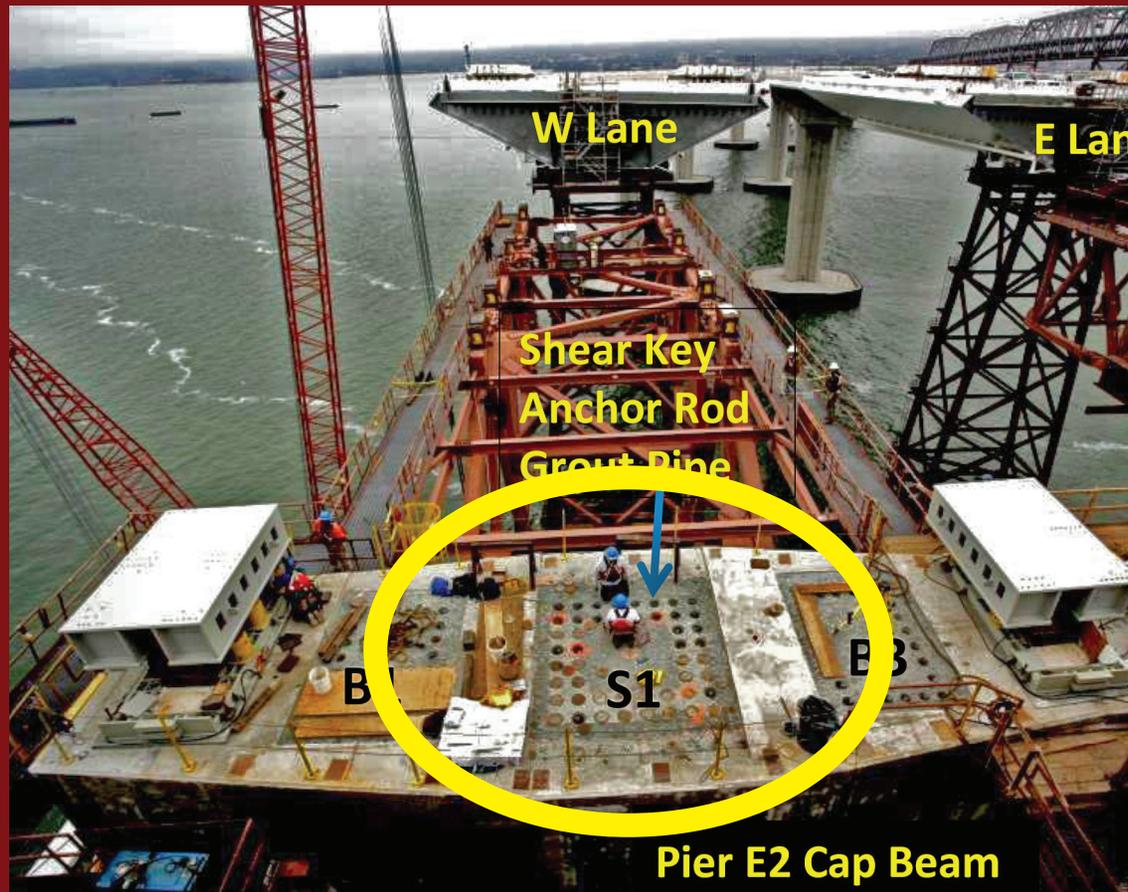
ACTUAL CAUSE

- ANCHOR RODS CORRODED BY INTRUSION OF WATER INTO OPEN GROUT PIPES
- HYDROGEN ATOMS FROM CORROSION OF ZINC LAYER DIFFUSED INTO THE STEEL
